Research Article

Comparative Analysis of Water Wells and Tap Water: Case Study from Lebanon, Baalbeck Region

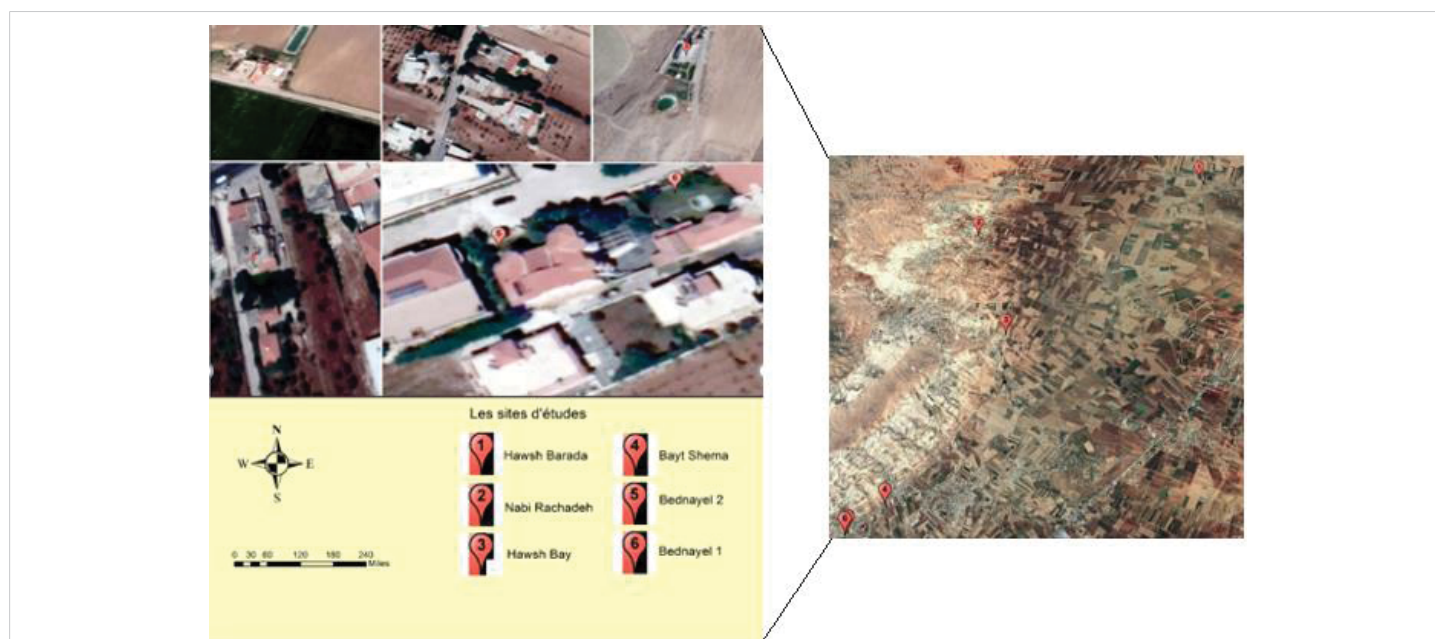
**Figure 1:** Map of sampling sites in the Eastern Bekaa region.**Table 2:** The different physicochemical parameters measured and the analysis methods.

The sampled water was collected from several sources in Baalbek Region and its surrounding. The region occupies more than 300.000 people where agriculture is the main activity. In the area of concern, there are several water sources, in addition to the groundwater aquifers, water the Litani River and from a number of man-made lakes. The selected sites are distributed over several villages, and the distance between wells is almost at few kilometres, as these well were dug under a decision made by the Ministry of Energy and Water. There are six sites selected, these are: Bednayel, Nabi-Rashadah, Tamnine, Hawsh Barada, and Taraya (Hawsh Bay) and Beit Shama. Both domestic and agricultural uses of water exist. Table 1 and Figure 1 describes the types of activities presented around each site, as well as the geographic coordinates and altitude.

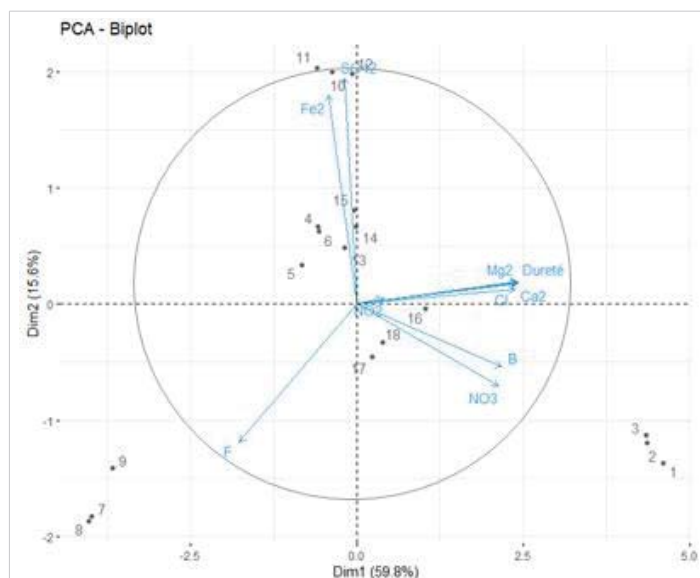
Figure 2: Diagram of the variables of individuals in space after rotation on axes 1 and 2.

The PCA diagram for parameters and individuals on axes 1 and 2 explains $\approx 75.4\%$ of the information and it has great importance.

From the Figure 2 (i.e., correlation circle), we can see that all parameters except (NO_2^-) are very close to the correlation circle and therefore very well represented on the PCA diagram. The rather closed angle (starting from the origin) formed by the parameters: NO_2^- , Mg^{2+} , Cl^- , Ca^{2+} , Hardness indicates that they are very well correlated with each other, and the same for the parameters: Fe^{2+} and SO_4^{2-} , and for the two parameters: NO_3^- and B^- .

Again we can notice the almost right angle formed by the parameters: NO_2^- , Mg^{2+} , Cl^- , Ca^{2+} , respectively with the parameters Fe^{2+} and SO_4^{2-} , indicates that they are independent of them. In addition, the parameter F- again is independent of all parameters.

-The sources of each site are contaminated and affected by chemical pollutants in an almost similar way (in similar quantities) as Figure 2 shows.
